# Aircraft Mishap Facts

## Second Half FY 84 Review

### Introduction

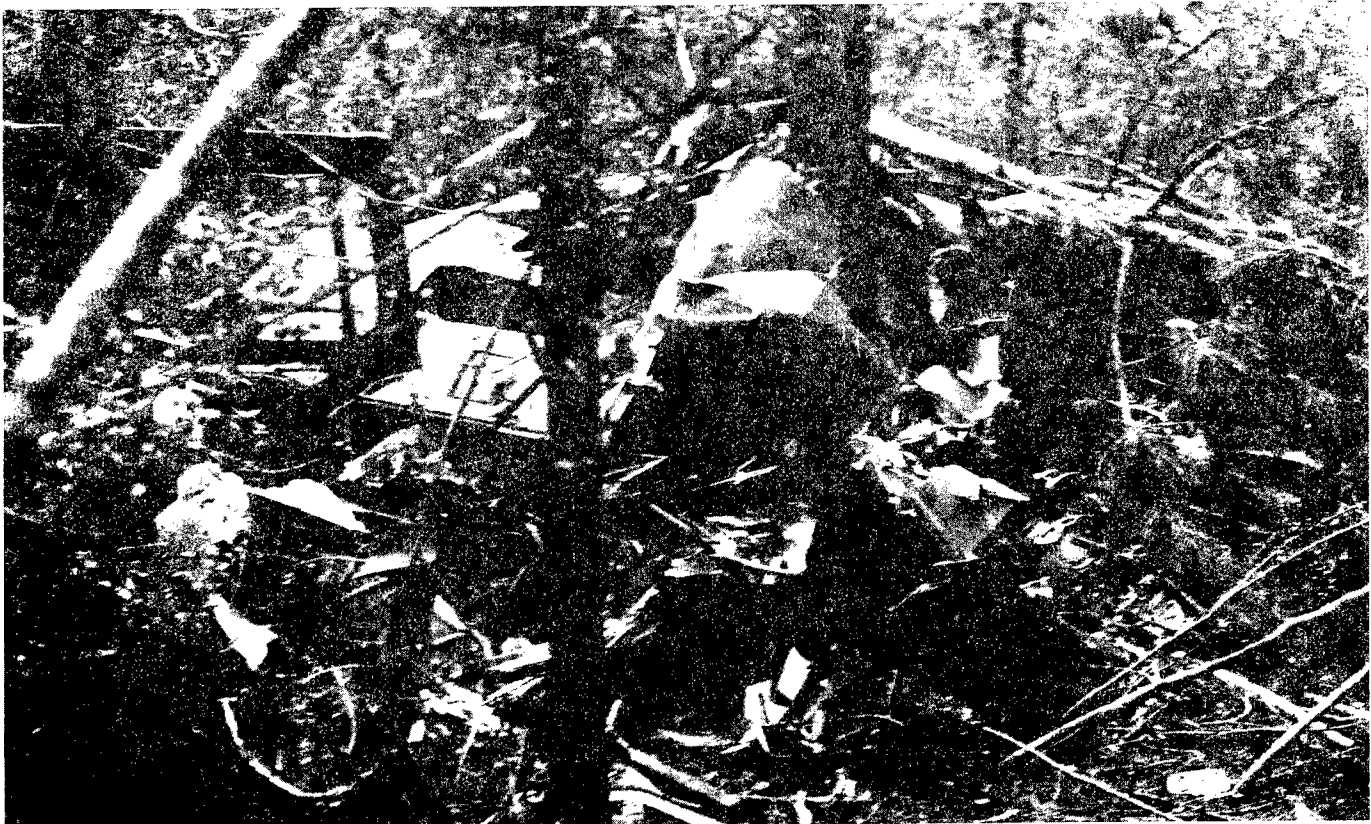
The instructor pilot of this UH-1 was unable to recover from a right roll.

**Cause:** During the right turn to crosswind, the IP, using the floor mike because of an inoperative cyclic communication switch,

communicated to the student pilot that the hydraulic switch was coming on. Because of climb power and a right crosswind, the student pilot had pressure exerted on the left pedal. As hydraulic power returned, the left pedal pressure had the servo spool valve at full travel and caused the servo to extend fully in less than one-half of a second. The tail rotor thrust, combined with the right cyclic applied, caused the aircraft to develop a right roll rate from which the IP was unable to recover. The IP was unable to block left pedal input because his right foot was on the floor mike.

**DA level:** Evaluate training requiring close crew coordination such as NOE or nonstandard maneuvers and determine if such training should be conducted only in aircraft with fully functional intercommunication systems. Evaluate the requirement to conduct hydraulics-off training. Change the warnings currently published in the operator's manual to be more explicit concerning the hazards involved in hydraulic malfunctions and hydraulics-off maneuvers. Expedite the product improvement proposal to install improved servos in the UH-1. Define the flight envelope in which the hydraulic switch could be safely returned to the on position and take action to ensure this is included in the appropriate aircrew training manual.

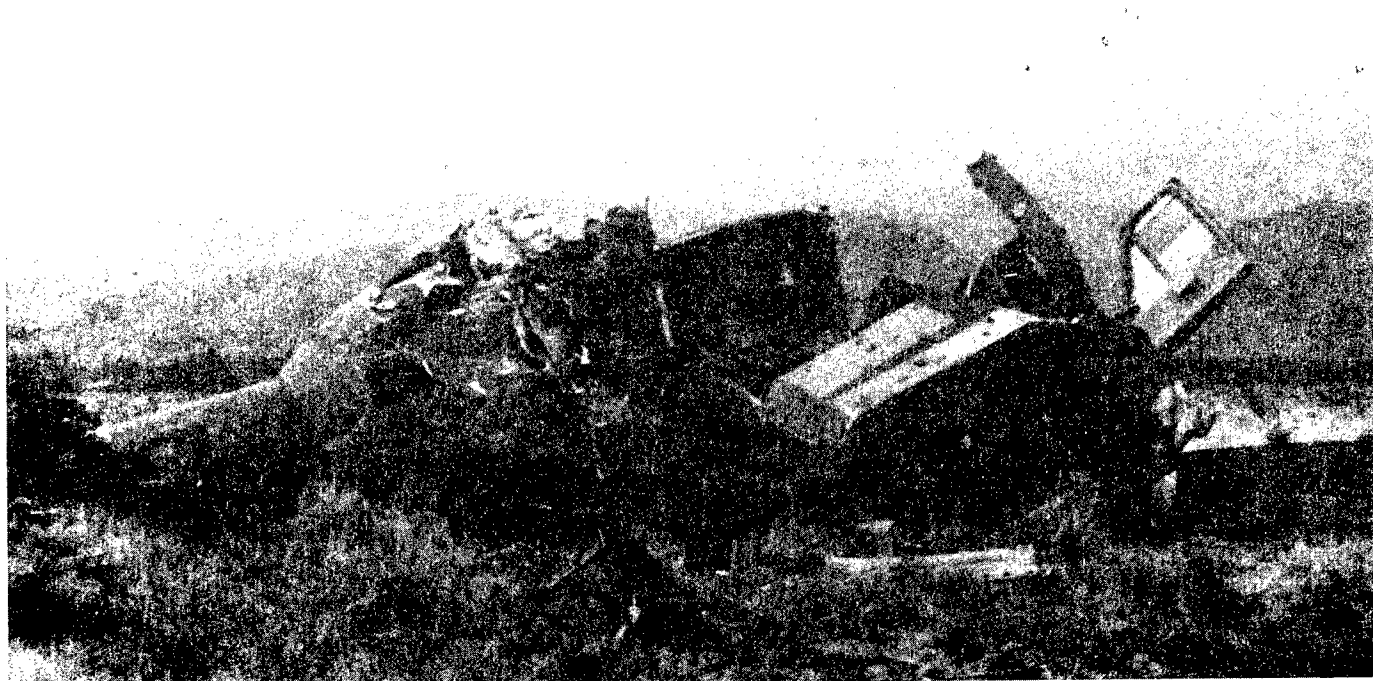
This UH-1 crashed as the pilot was performing a maneuver prohibited by regulations.

**Cause:** The pilot performed a maneuver prohibited by regulations which resulted in an excessive rate of descent that could not be stopped before ground impact.

**Unit level:** Brief assigned personnel on the need to maintain strict air discipline with respect to regulations, rules, and professional standards of conduct. Evaluate the pilot of this aircraft to determine his fitness to continue on flight status.

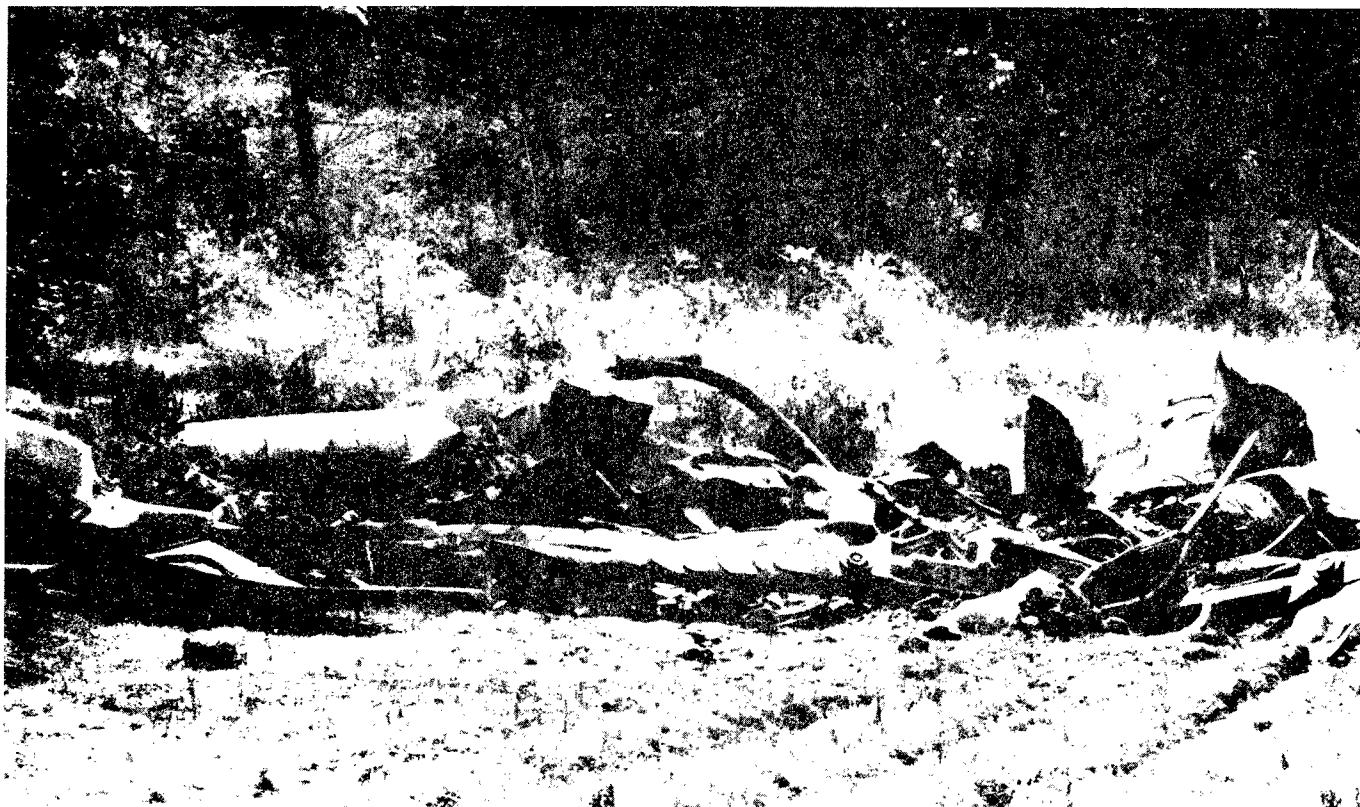
The engine of this UH-1 failed while the pilot was making a power recovery from an autorotative descent.

**Cause:** Engine failure was caused by corrosion on the No. 1 main bearing. The engine had been allowed to sit for about a year without being properly preserved for storage.

**Higher level:** Ensure subordinate units comply with existing maintenance directives. Consider the establishment of a periodic unit-level maintenance evaluation.

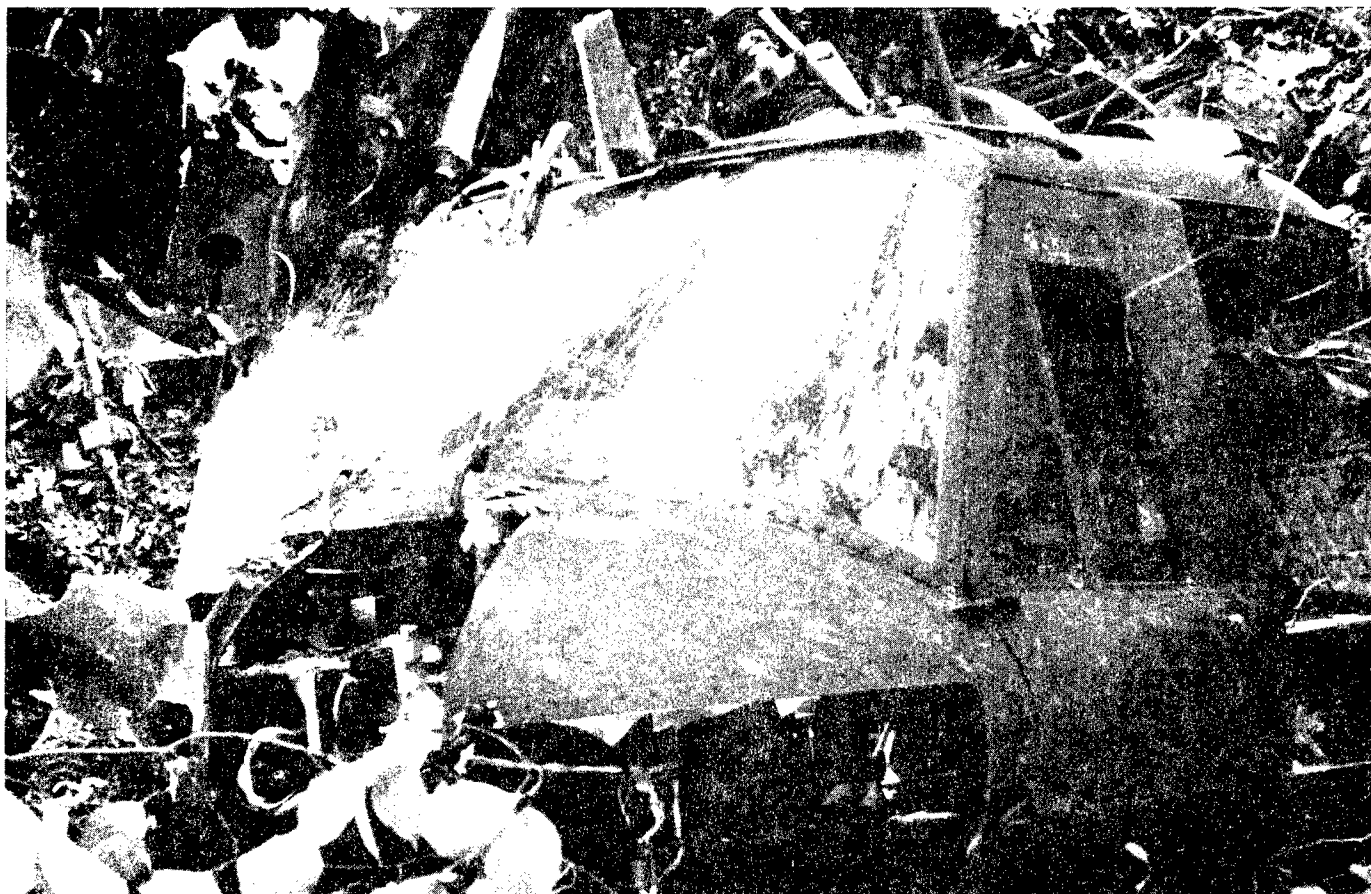
Engine rpm decreased during low-level flight, and UH-1 settled into trees.

**Cause:** The exact cause of the decreased engine performance could not be established through teardown and analysis efforts.

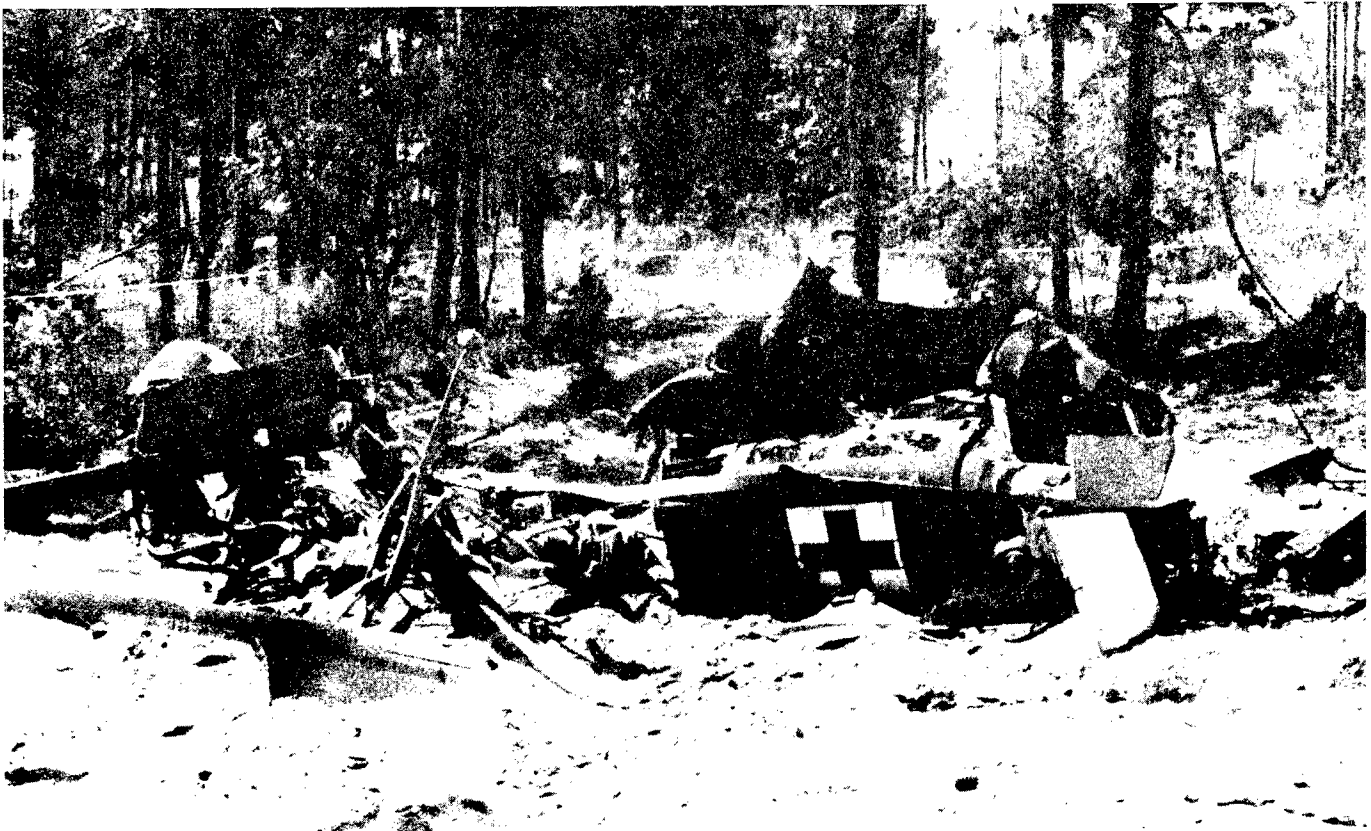
UH-1 crew lost visual reference with the ground while landing on an unimproved dusty road.

**Cause:** The copilot did not make an adequate reconnaissance of the area

and landed on an unimproved dusty road rather than a larger grassy area next to the road. On short final, the copilot realized the suitability of the landing site was questionable but delayed making a decision to go around or continue the approach to the ground until the aircraft became engulfed in dust. The copilot's concern about the injured soldier may have caused him to take shortcuts in procedures. The pilot did not properly supervise the flight or communicate with the copilot on short final.

**Unit level:** Ensure pilots realize that successful completion of the mission is of prime importance and that real or perceived urgency of the mission is not a reason to jeopardize the safety of the crew. Ensure that pilots on pilot-in-command orders realize that, regardless of the copilot's qualifications, the PIC has the responsibility of ensuring that correct procedures are followed.

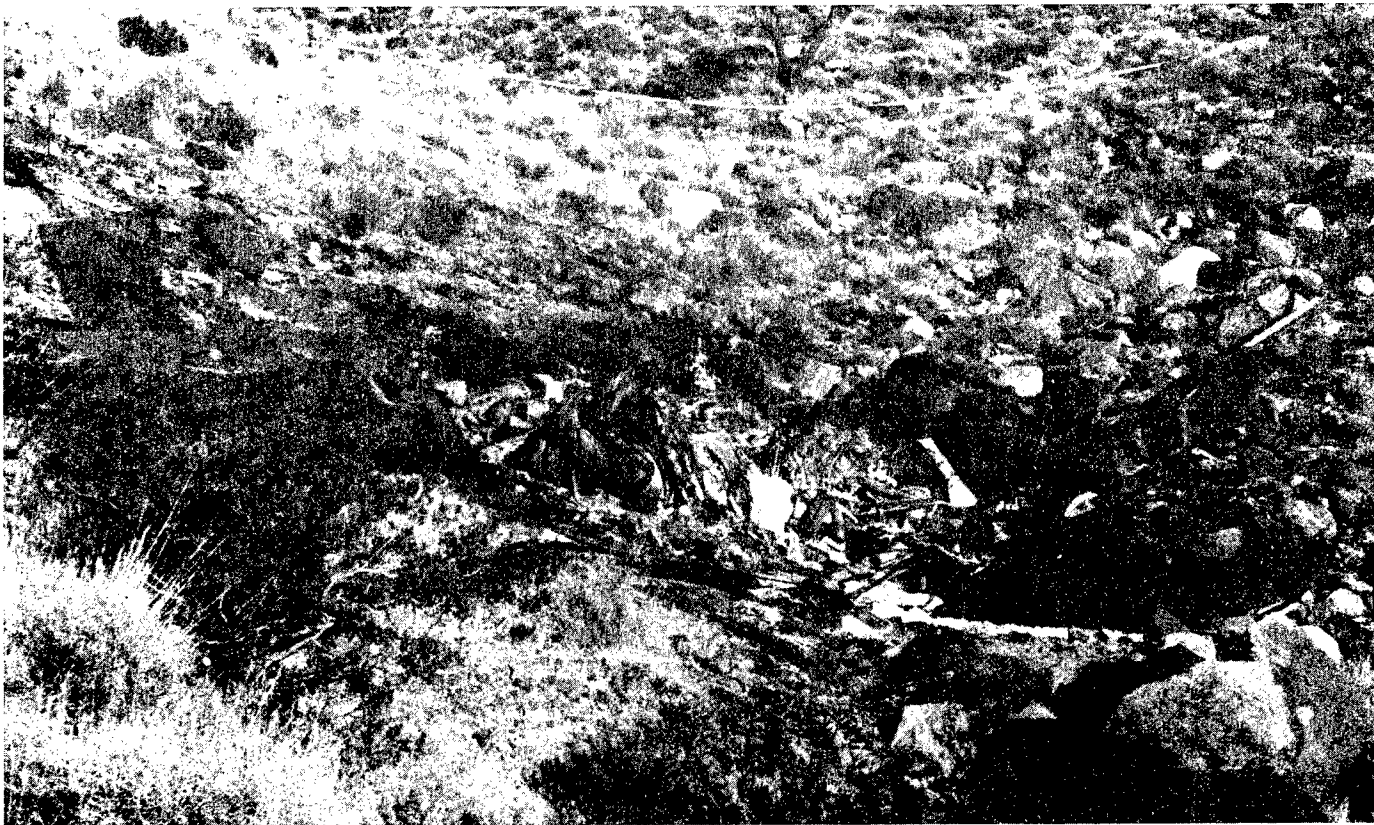
UH-1 crashed and burned when compressor section of engine failed during approach for landing.

felt a vibration and elected to make a go-around. As this maneuver was initiated, the compressor section of the engine failed. Power to maintain flight was lost, and the crew entered autorotation. The aircraft touched down on a slope, rotated 180 degrees about the lateral axis, and came to rest inverted. A postcrash fire destroyed the aircraft.

**Cause:** Materiel failure of the compressor section of the engine.

**Unit level:** Brief all personnel on the facts and circumstances surrounding this mishap, stressing the importance of immediately following the actions outlined in the operator's manual during an emergency.

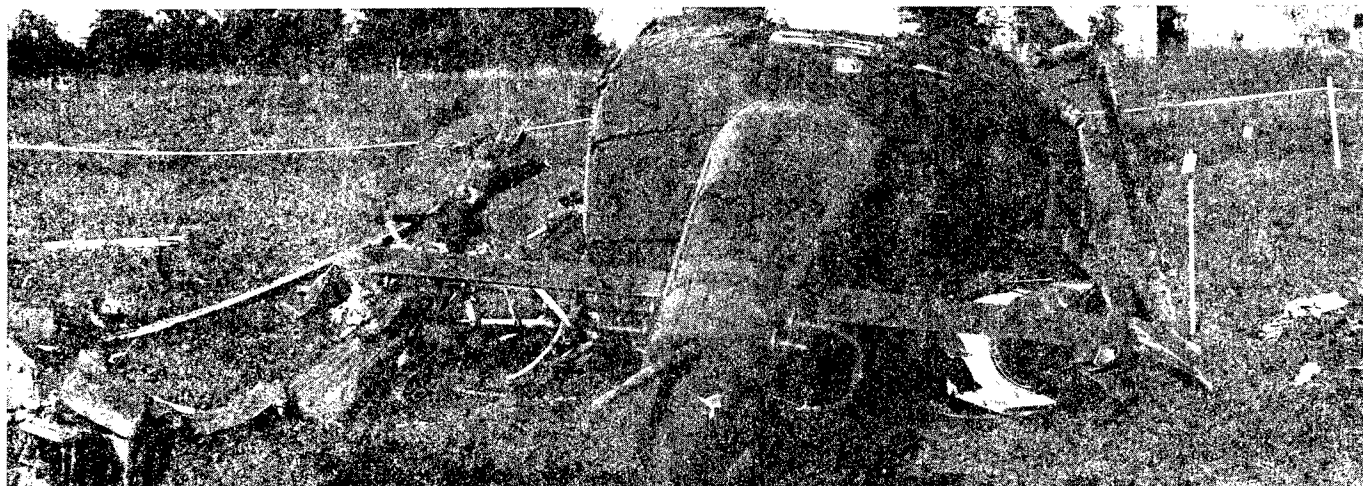
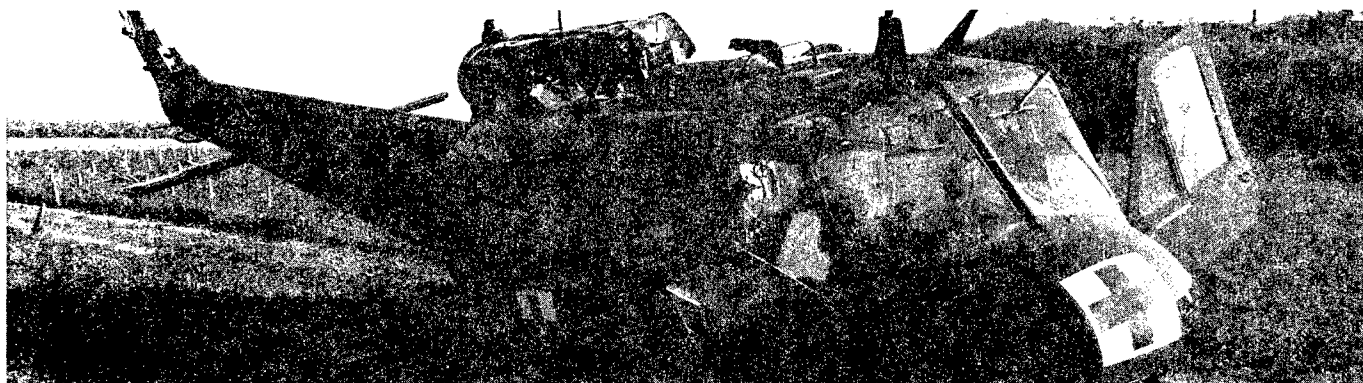
The rotor blades of these two UH-1 helicopters meshed during an unauthorized maneuver. Top photo shows the damage to the wing aircraft, and bottom photo shows the damage to the lead aircraft.

**Cause:** The type maneuver being flown is prohibited by AR 360-61, AR 95-1, local regulations, and standing operating procedures. The route of flight was not a properly designated low-level route. The pilot of the wing aircraft failed to follow procedures outlined in TC 1-201, Tactical Flight Procedures. He was flying below and virtually side by side the lead aircraft with blade overlap. The copilot of the wing aircraft did not tell the pilot they were too close to the other aircraft. The relatively inexperienced copilot had not been briefed concerning the maneuver and what his duties would be. The mission commander, who was the copilot of the lead aircraft, did not realize that the maneuver was unauthorized or dangerous and made no attempt to abort the maneuver.

**Higher level:** Ensure that subordinate units are complying with regulations and directives. Reemphasize command policies concerning flybys to all subordinate units. Ensure that units are complying with DA message DACS-ZB151330Z Mar 84, subject: Minimum Elements of the Aircrew Mission and the Mission Briefback.

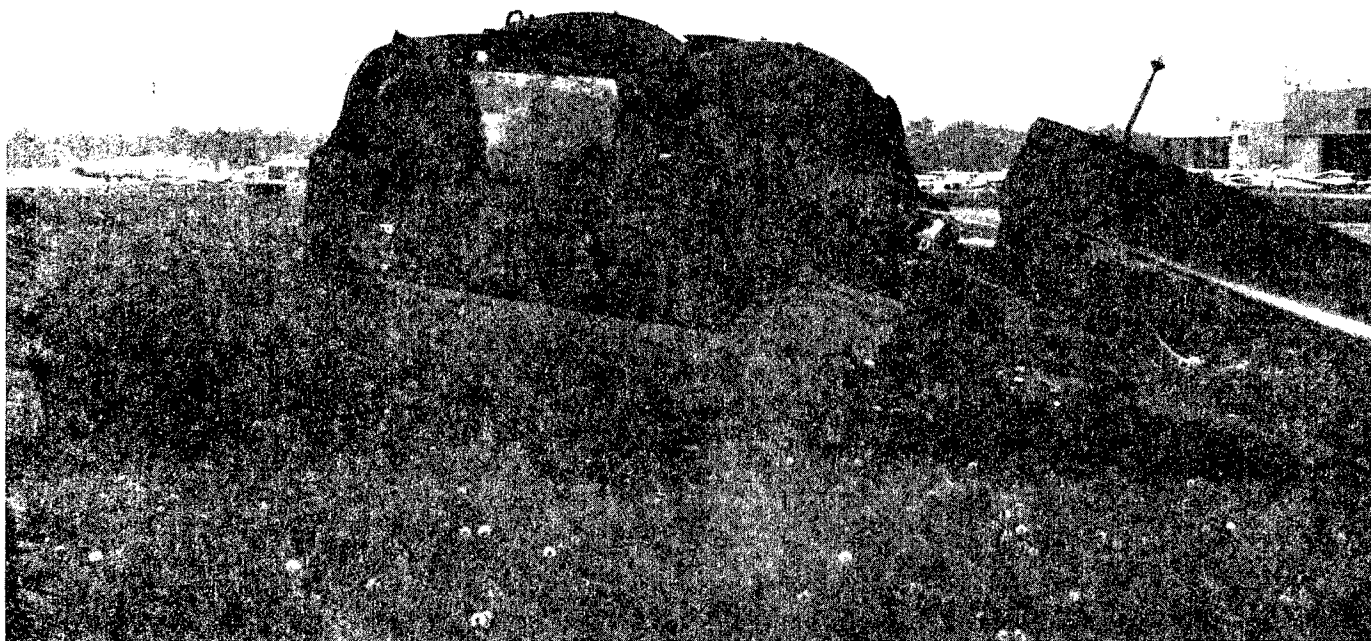
UH-1 copilot applied too much collective pitch during hover and aircraft crashed.

**Cause:** The inexperienced copilot lost his composure and overcontrolled the aircraft. The pilot did not take and keep positive control of the aircraft. He was overconfident in the ability of the copilot to handle the situation and was accustomed to flying with experienced pilots who did not require assistance.

**Unit level:** Emphasize to unit aviators the hazards involved and precautions to be taken when hovering downwind in formation and the necessity to remain calm under all conditions. Ensure designated pilots-in-command are aware of their responsibilities for the safe operation of their aircraft.

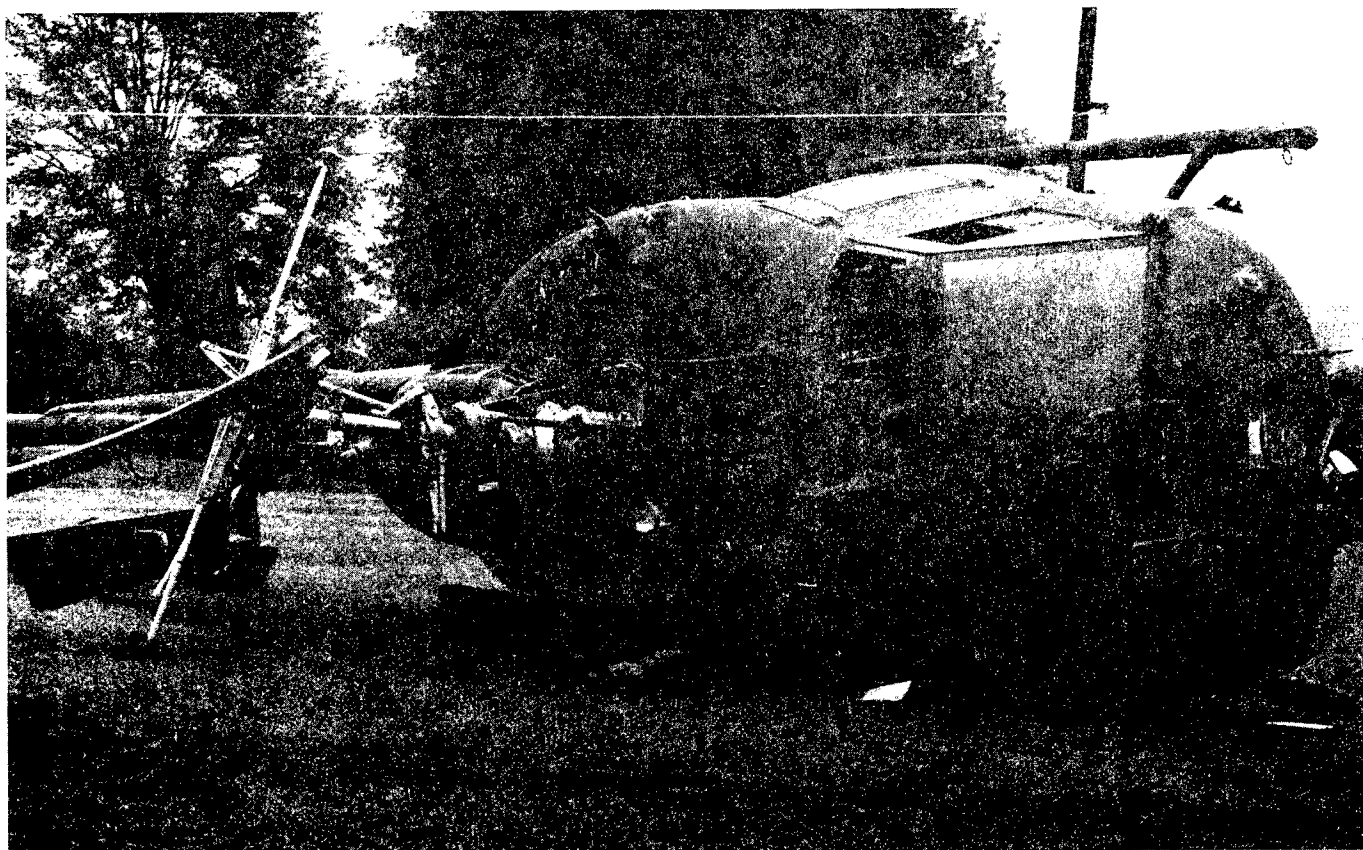
As UH-1 instructor pilot was hovering the aircraft while looking through the right rear cargo door, right landing gear hit the ground. Aircraft rolled onto right side.

As a UH-1 IP and two student pilots were taking off from a landing zone, the IP failed to maintain ground reference. The right landing gear assembly hit the ground during right sideward flight, and the aircraft entered dynamic rollover and came to rest on its right side.

**Cause:** The IP, who was flying from the left seat, was hovering the aircraft while looking through the right rear cargo door. He did not detect the initial warning signs of dynamic rollover. The IP self-induced a task overload on himself by not using his students to provide visual obstruction clearance.

**Unit level:** Require aircrews to operate aircraft using established flight techniques and to perform adequate premission briefings which will effect maximum crew coordination.

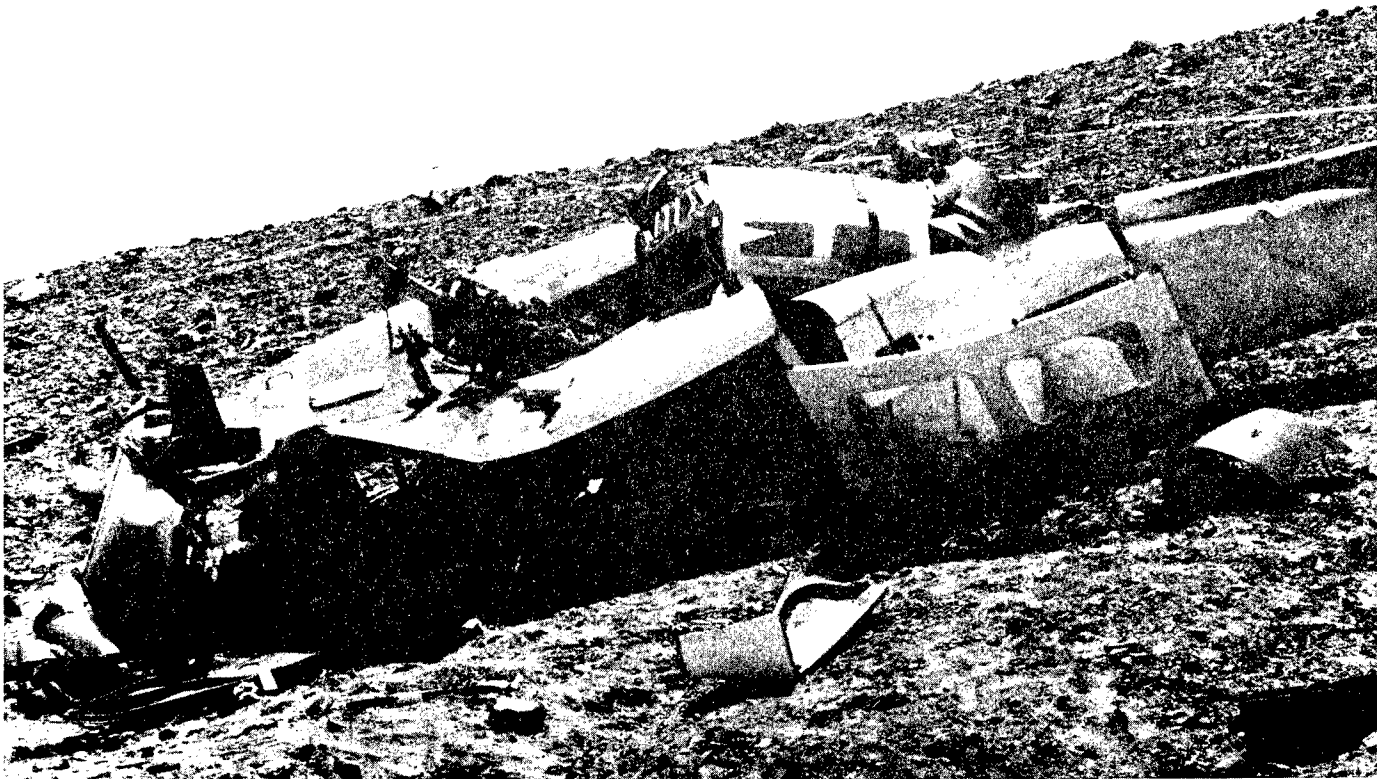
UH-1 crashed when the pitch change link clevis of the red main rotor blade broke.

**Cause:** The pitch change link clevis of the red main rotor blade broke because of long-term fatigue fracturing of the outer two-thirds of the threaded portion of the clevis. The remaining one-third of the cross-section failed due to overstress, as it

was unable to carry the load designed for the whole component. Design of the clevis was a primary factor in the failure in that the blind lightening hole prevented detection of the crack during the required magnetic particle inspection at the time of manufacture.

**DA level:** Identify all existing faulty pitch change link clevises in use and in supply stocks and remove them from service. Review contractor quality control procedures to ensure that all required actions are completed to a 100 percent accuracy level. Delete the lightening hole within the shank from the clevis design requirements. This change to the clevis design would enhance nondestructive testing inspection of the clevis by lessening the possibility of cracks going undetected within the blind hole and eliminate an existing corrosion problem within the lightening hole.

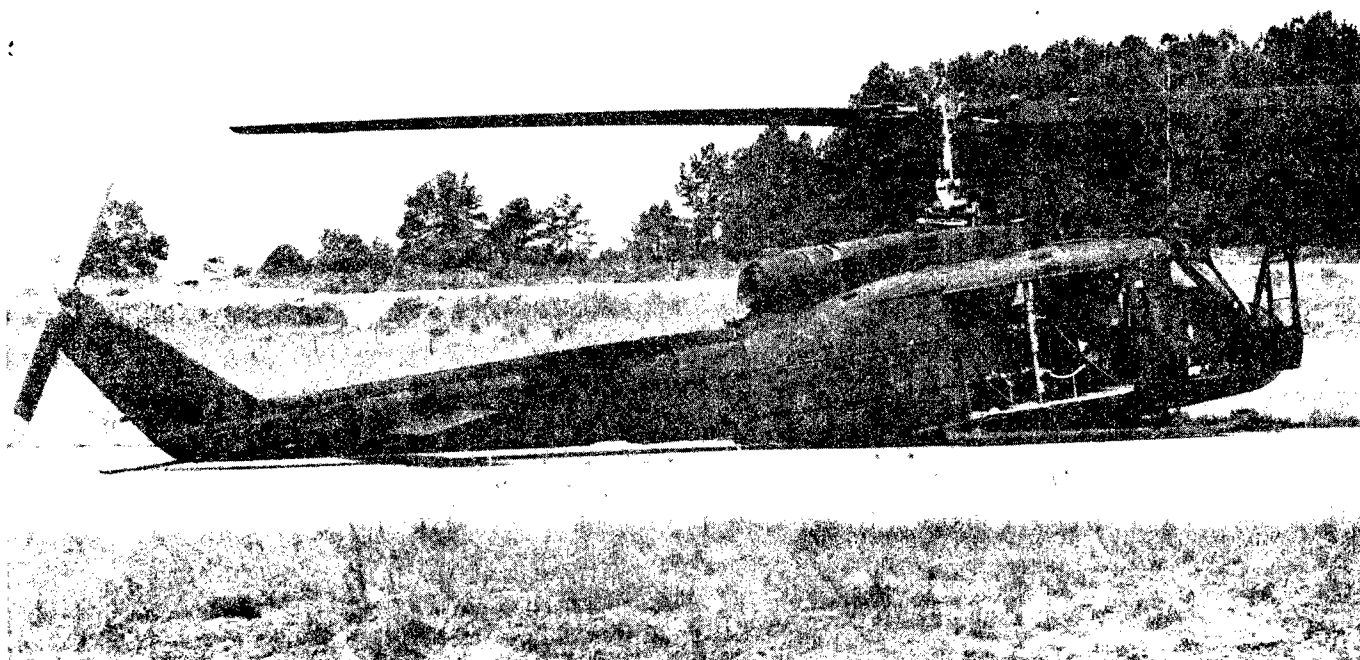
UH-1 pilot thought he had a tail rotor malfunction and entered autorotation. Aircraft was damaged during hard landing.

**Cause:** The pilot incorrectly identified the cause of the loud bang and induced a situation from which he could not recover. It was concluded that the banging sound was produced by a seatbelt which was not secured.

**Unit level:** Continue to critically assess all pilots' ability to soundly evaluate emergency situations and

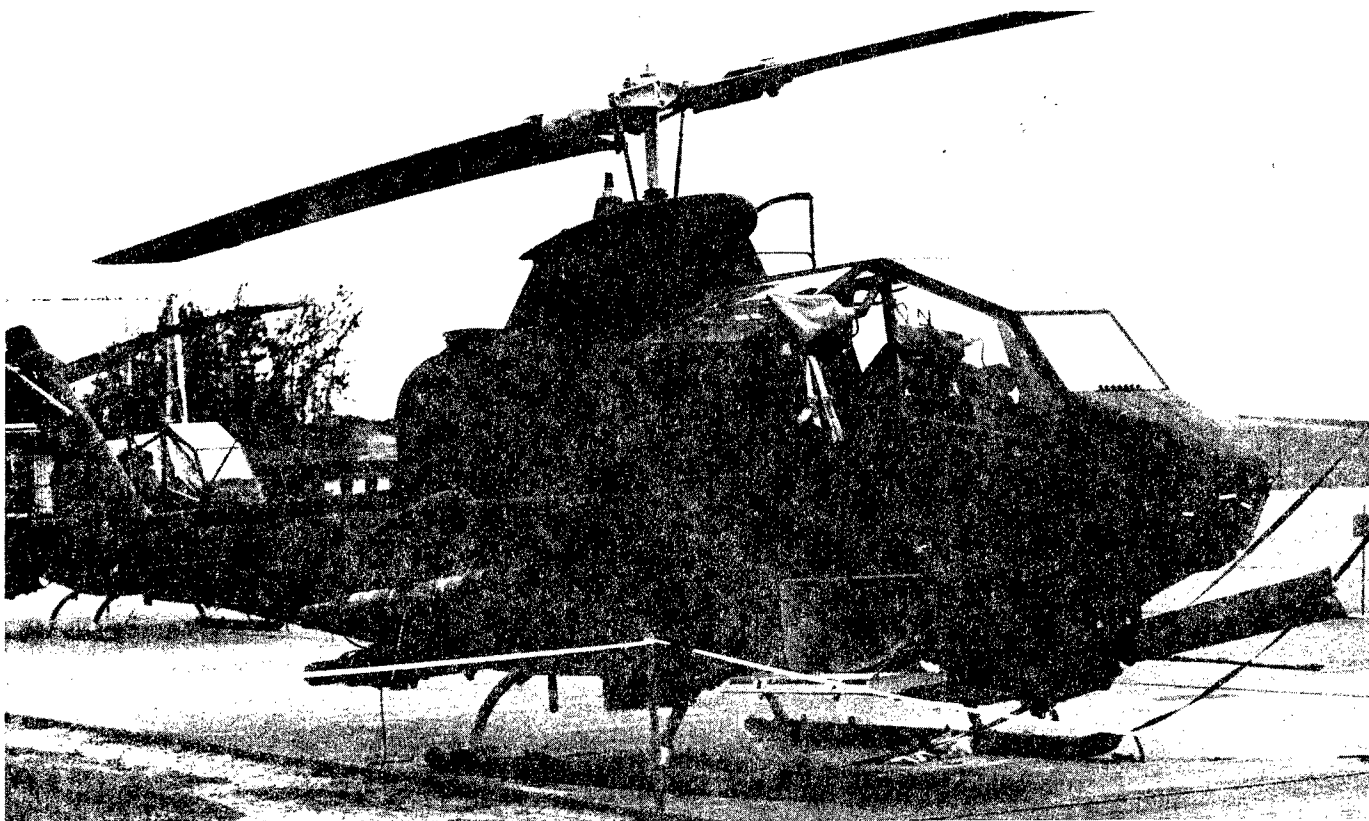
A maintenance technician running up this AH-1 could not maintain directional control. As the aircraft was turning, it hit another technician kneeling on the ground.

**Cause:** The maintenance technician failed to maintain directional control of the aircraft because of inadequate training. The training program developed by the facility was consistent with guidance provided by higher headquarters.

**DA level:** Revise AR 95-1 to prohibit nonrated personnel from performing ground runups in rotary wing aircraft.

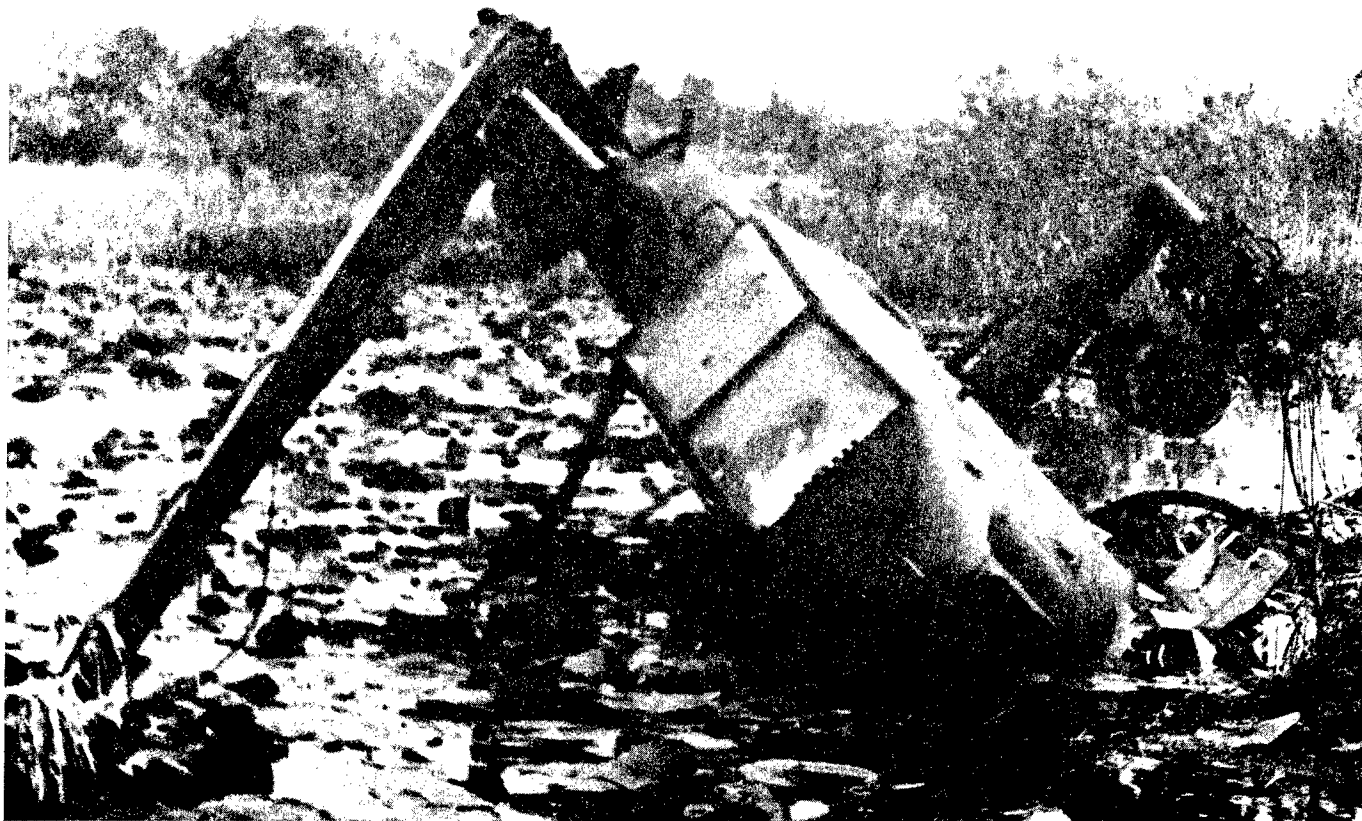
AH-1 main drive shaft failed during flight. Pilot entered autorotation and landed in a marshy area.

As the AH-1 was in cruise flight at about 1,000 feet agl, a loud bang was heard from the aft section of the aircraft, followed by a grinding noise. The aircraft yawed left, and the crew noted an increase in engine rpm and a decrease in main rotor rpm. The pilot entered autorotation and selected the best available landing site, which appeared to be a field. The pilot made a zero ground run landing to the site, which was a marshy area. As the aircraft settled into 4 feet of water, the right skid sank deeper than the left and the aircraft leaned to the right, causing the advancing main rotor blade to hit the mud and water

**Cause:** Failure of the main drive shaft was caused by insufficient lubrication. After an extensive storage period, the drive shaft was returned to the active supply channel without being inspected for adequate lubrication and without being freshly lubricated.

**DA level:** Ensure the improvement of quality control of overhauled drive shafts by inspecting and repacking, if necessary, those drive shafts with a storage history before putting them into service. Accelerate the K-flex drive shaft modification for the AH-1S, thus eliminating the necessity for lubricated main drive shafts.

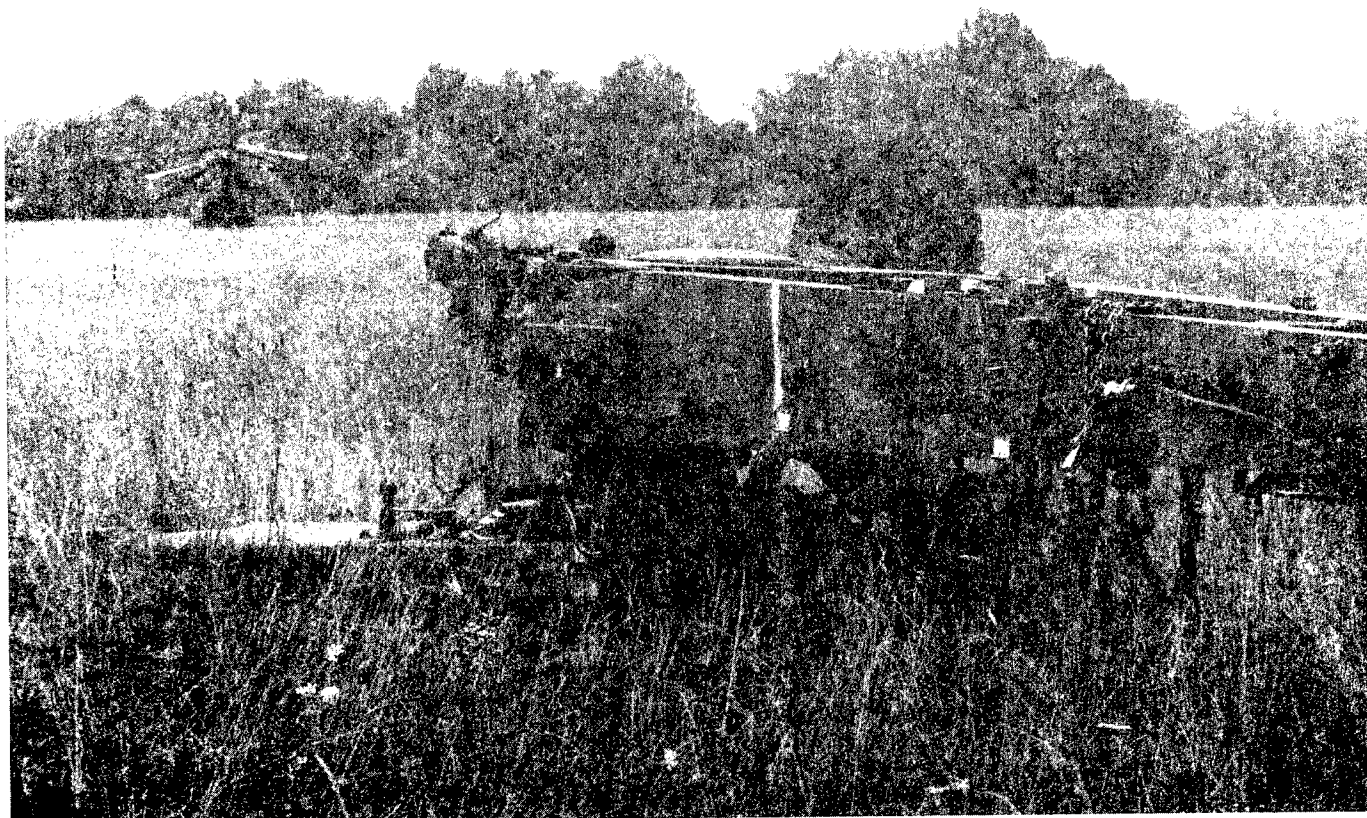
CH-47 was slingloading this Howitzer when torque split occurred. Pilot released the Howitzer and landed.

**Cause:** The torque split occurred because of a defective torque indication system that could not be discovered during normal operations. The No. 2 engine droop eliminator connection No. 3 was loose. This could have caused the rotor droop to occur with the initial torque split, but this could not be definitely established.

**Unit level:** Brief assigned personnel about this accident and continue to troubleshoot the torque indication system and correct the deficiency.

**DA level:** Determine cause of N2 assembly shortcomings and correct them.

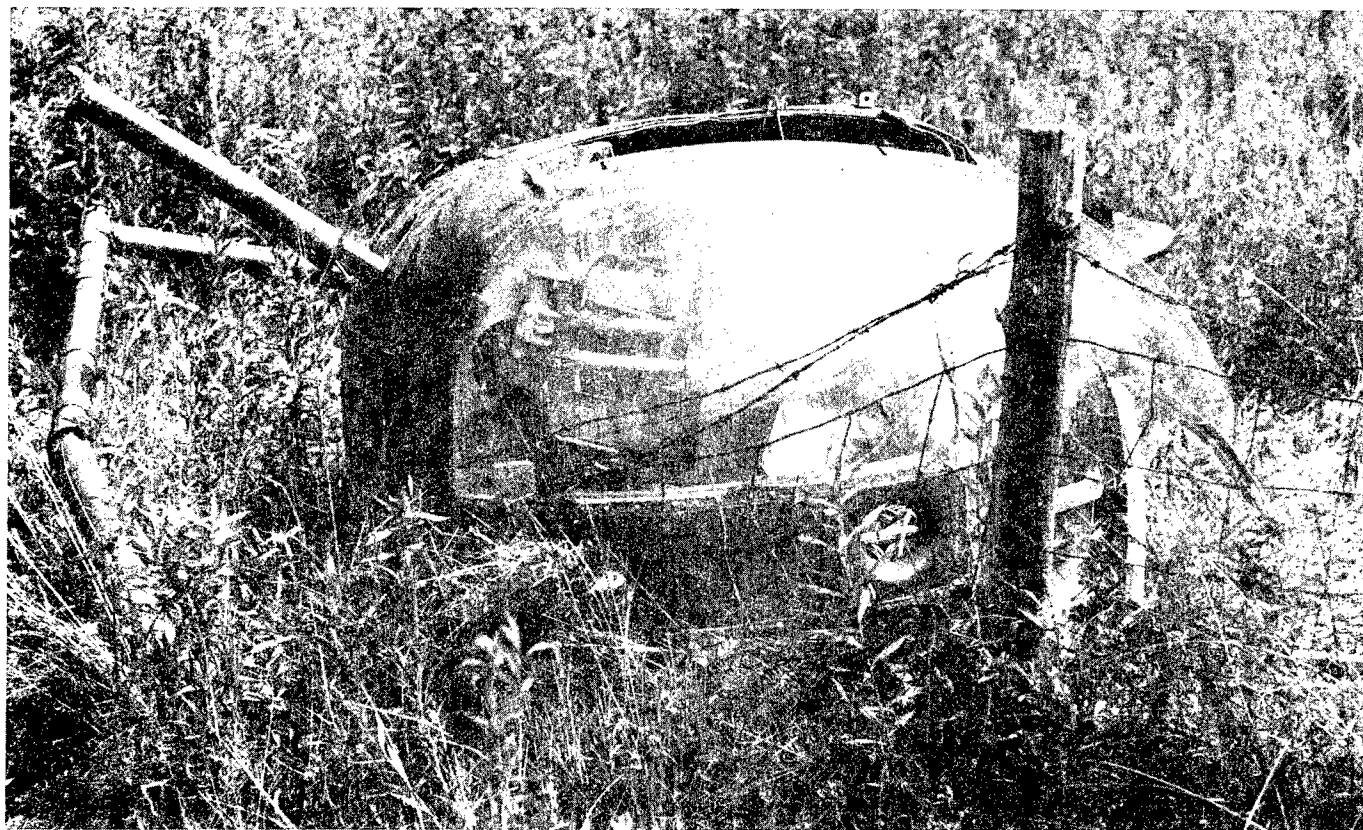
OH-6 hit wires and crashed while flying 130 feet above the ground.

**Cause:** Contrary to command regulation, the pilot was flying too low. His attention was divided between trying to fly the aircraft, navigating, and communicating with the passengers using written messages. He was also probably trying to spot the escaped convicts. There was no qualified observer on board, and neither of the passengers had any way to communicate with the pilot over the aircraft intercommunication system.

**Higher level:** Ensure that details of the mission necessary for adequate planning are provided in conjunction with mission assignment.

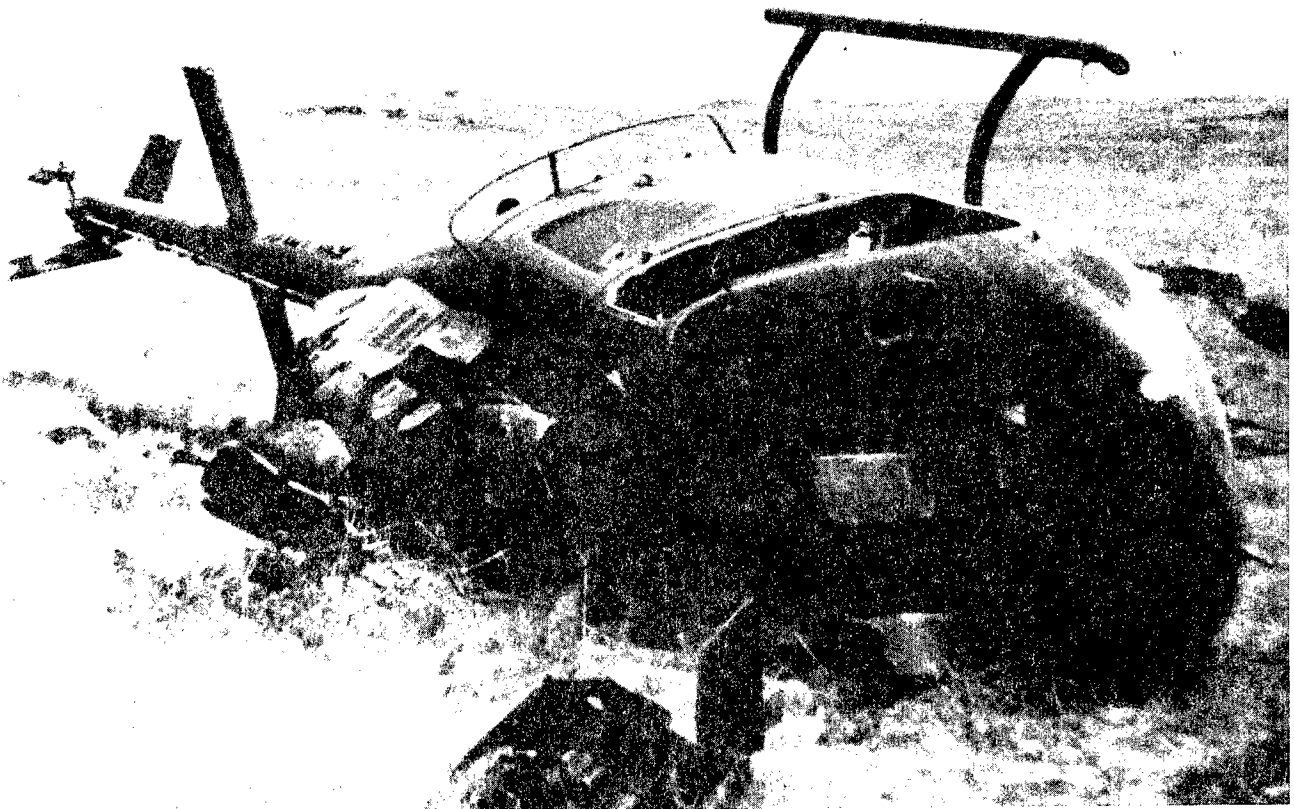
OH-58 pilot induced dynamic rollover while bringing the aircraft to a hover.

**Cause:** The pilot's attention was directed to his right rear and he induced dynamic rollover while bringing the aircraft to a hover. The pilot may have been fatigued. He had exceeded the allowable flight time for a 7-day period by 14 hours. He had just finished a 6½-hour continuous flight and had slept only 3½ hours the night before the accident.

**Unit level:** Inform personnel about the consequences of inadequate attention. Stress the need to perform all tasks in accordance with applicable rules, regulations, and basic flying techniques. Establish a definite crew rest policy and designate individuals within the chain of command to monitor and take appropriate action concerning crew rest.

**Higher level:** Ensure unit commanders establish and monitor a crew rest policy to avoid fatigue-induced errors.

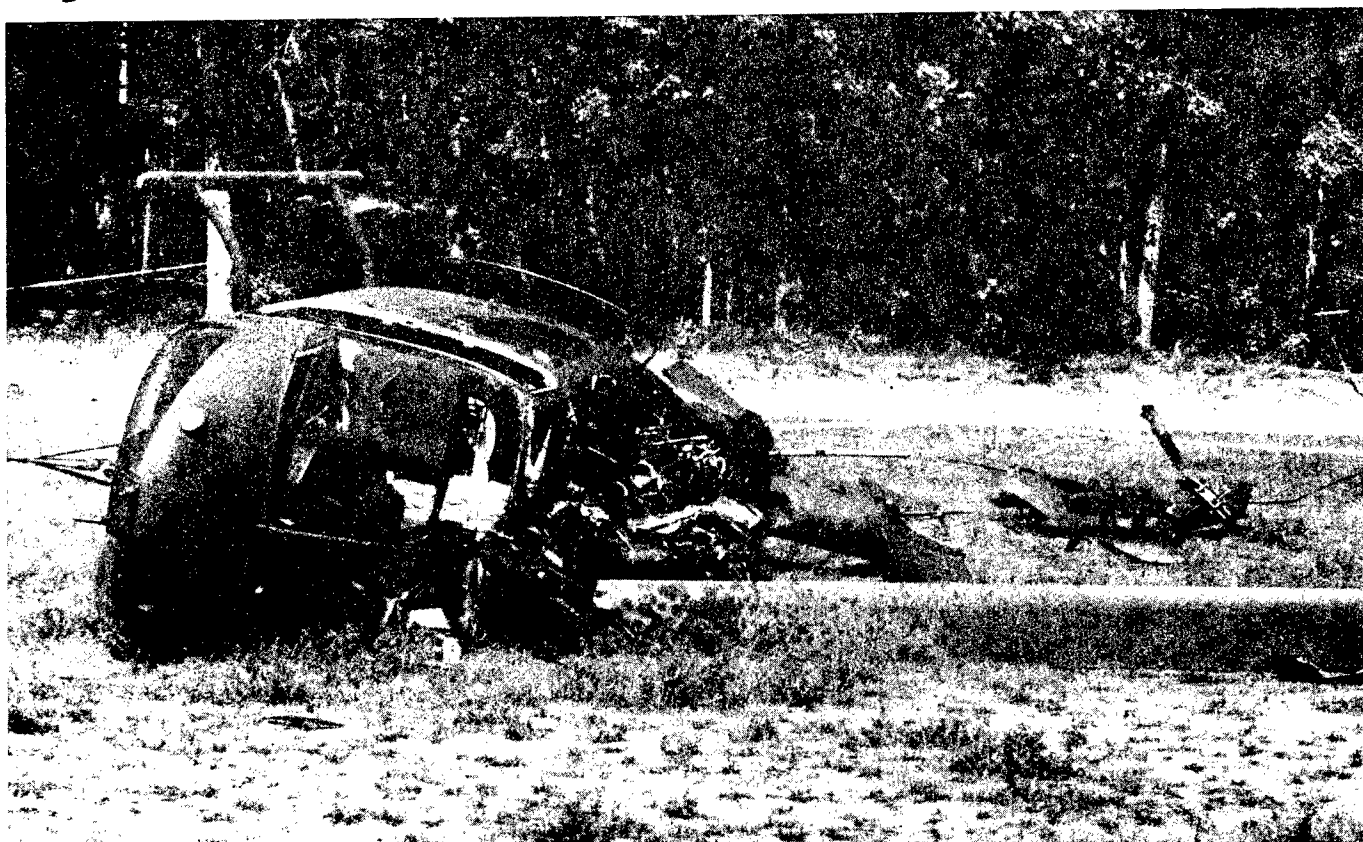
OH-58 pilot brought the aircraft to a hover and began a right turn. Right skid hit the ground and aircraft rolled over.

ground hard enough to cause a roll to the right and result in dynamic rollover. The impact of the advancing blade with the ground caused the helicopter to rebound sharply to the left and roll onto its left side.

**Cause:** Suspect the pilot misjudged the clearance between the skid and the ground and dynamic rollover occurred.

**Unit level:** Stress to unit aviators the importance of maintaining the hover tolerances specified in TC 1-137.
